AFML-TR-79-4209

FATIGUE CRACK PROPAGATION AND CORROSION
FATIGUE OF AF 1410 STEEL

S. D. ANTOLOVICH

JANUARY 1980

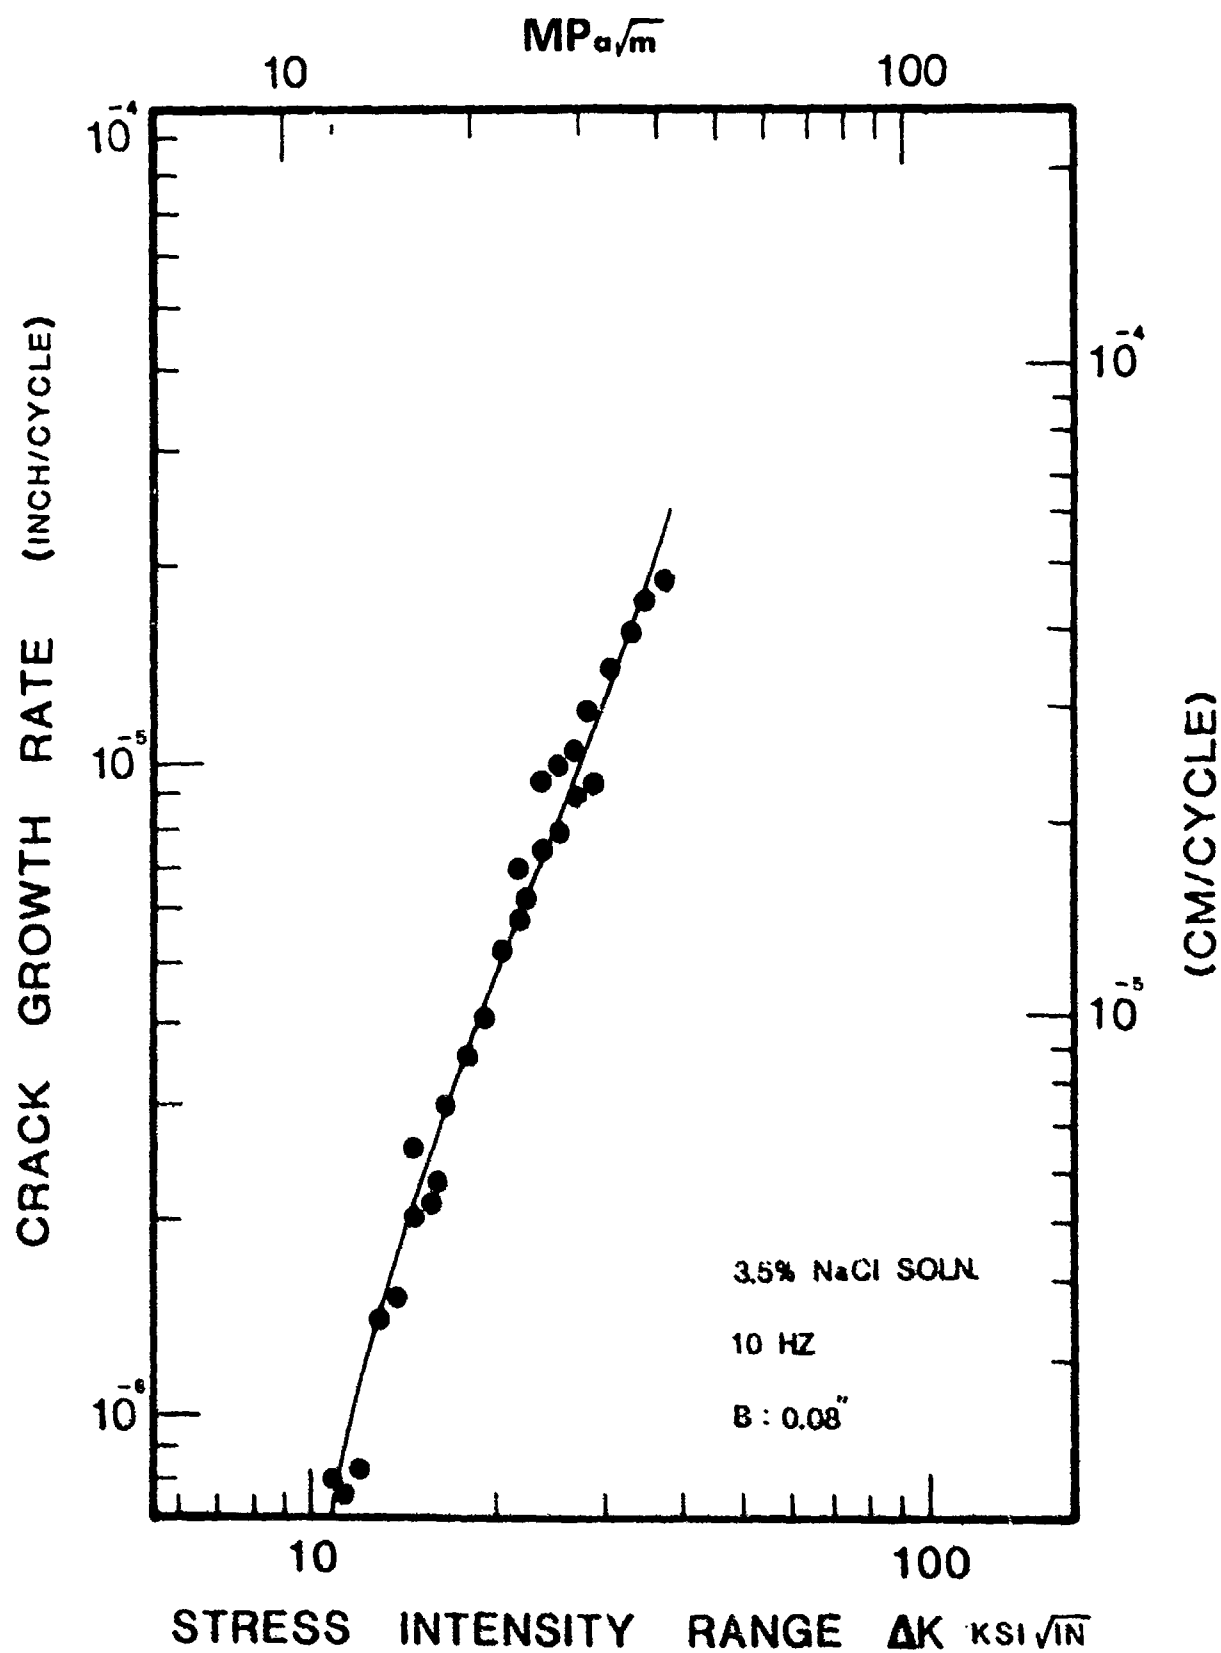
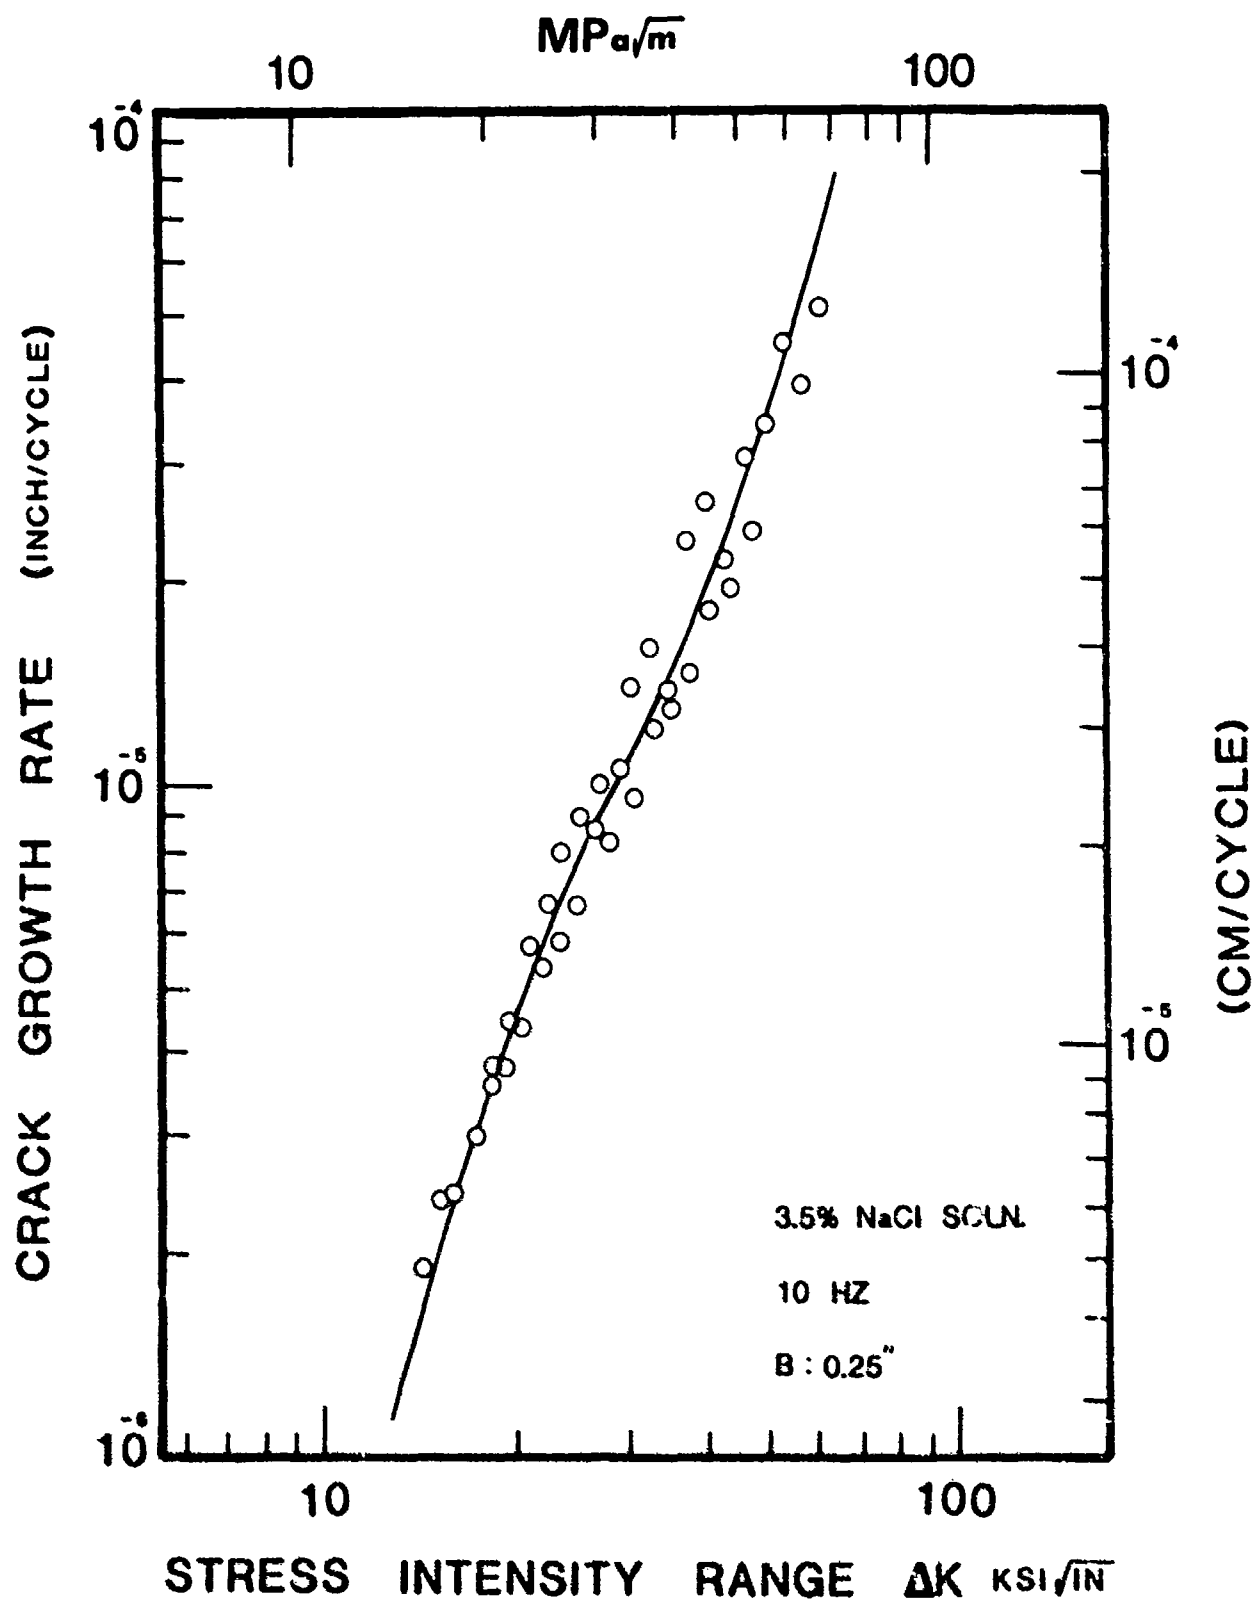
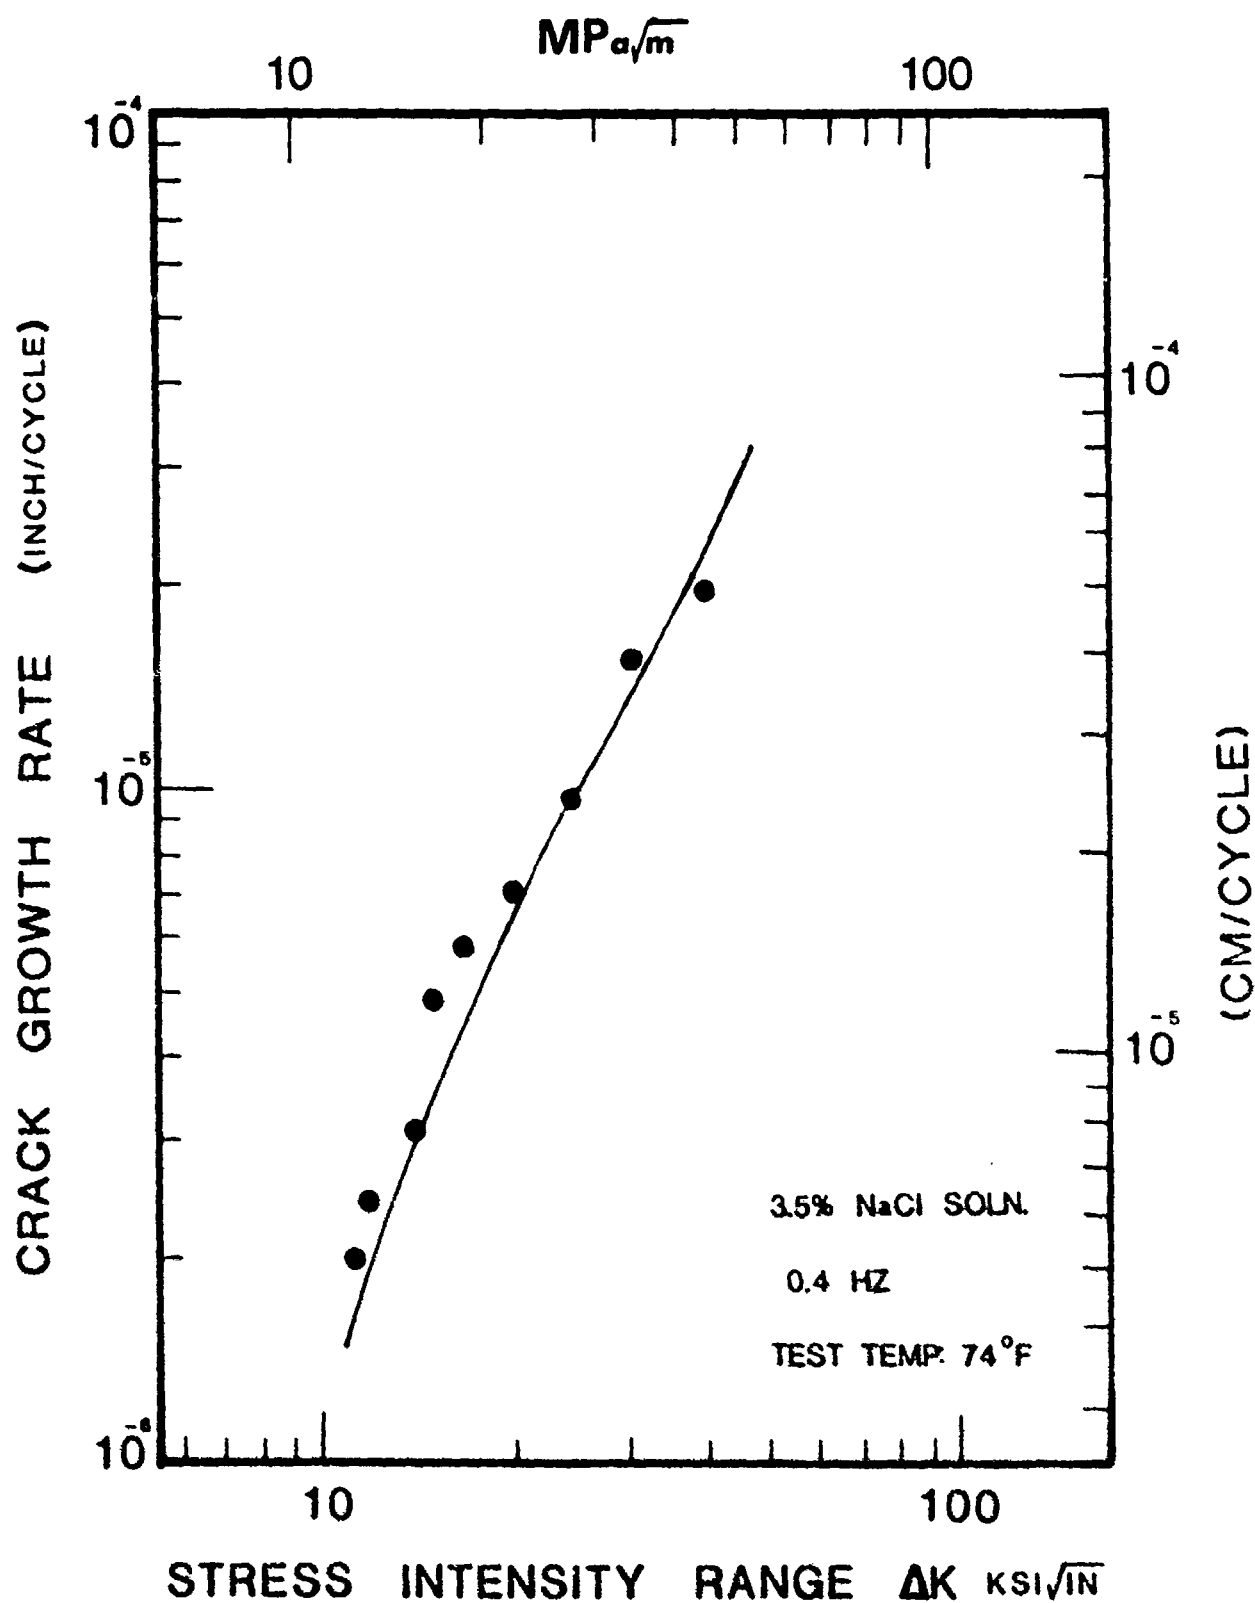
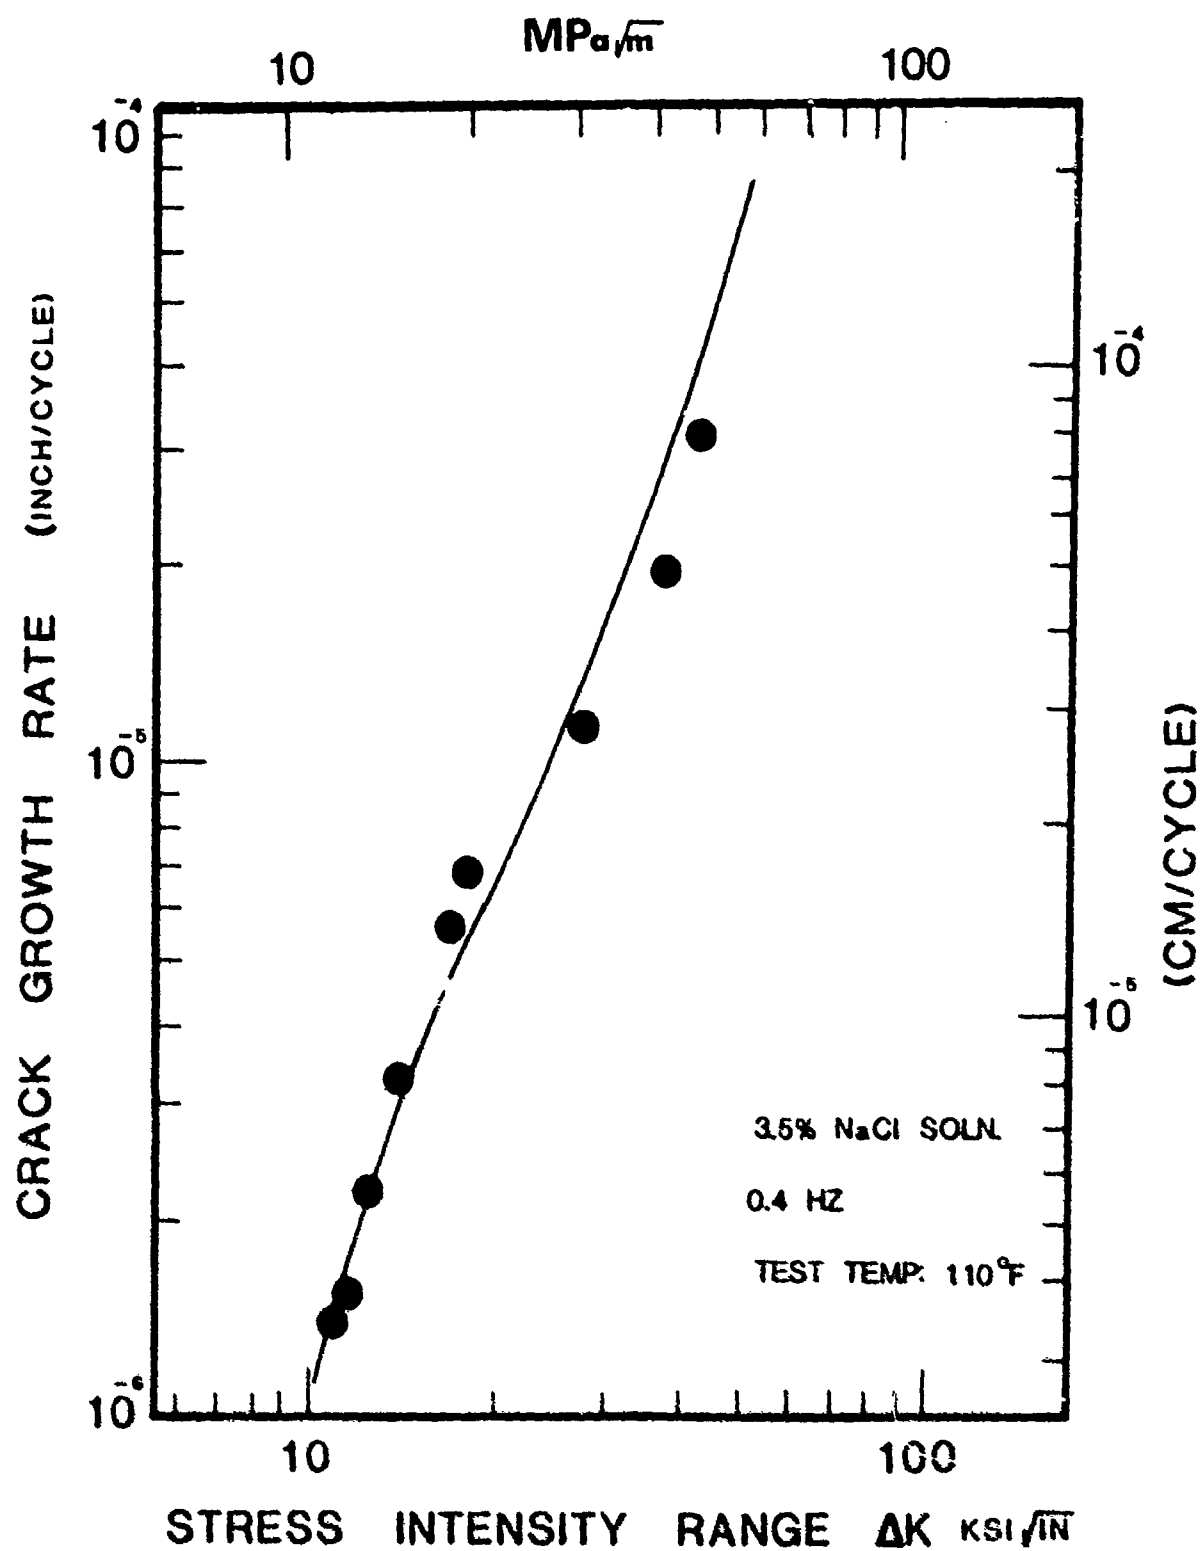
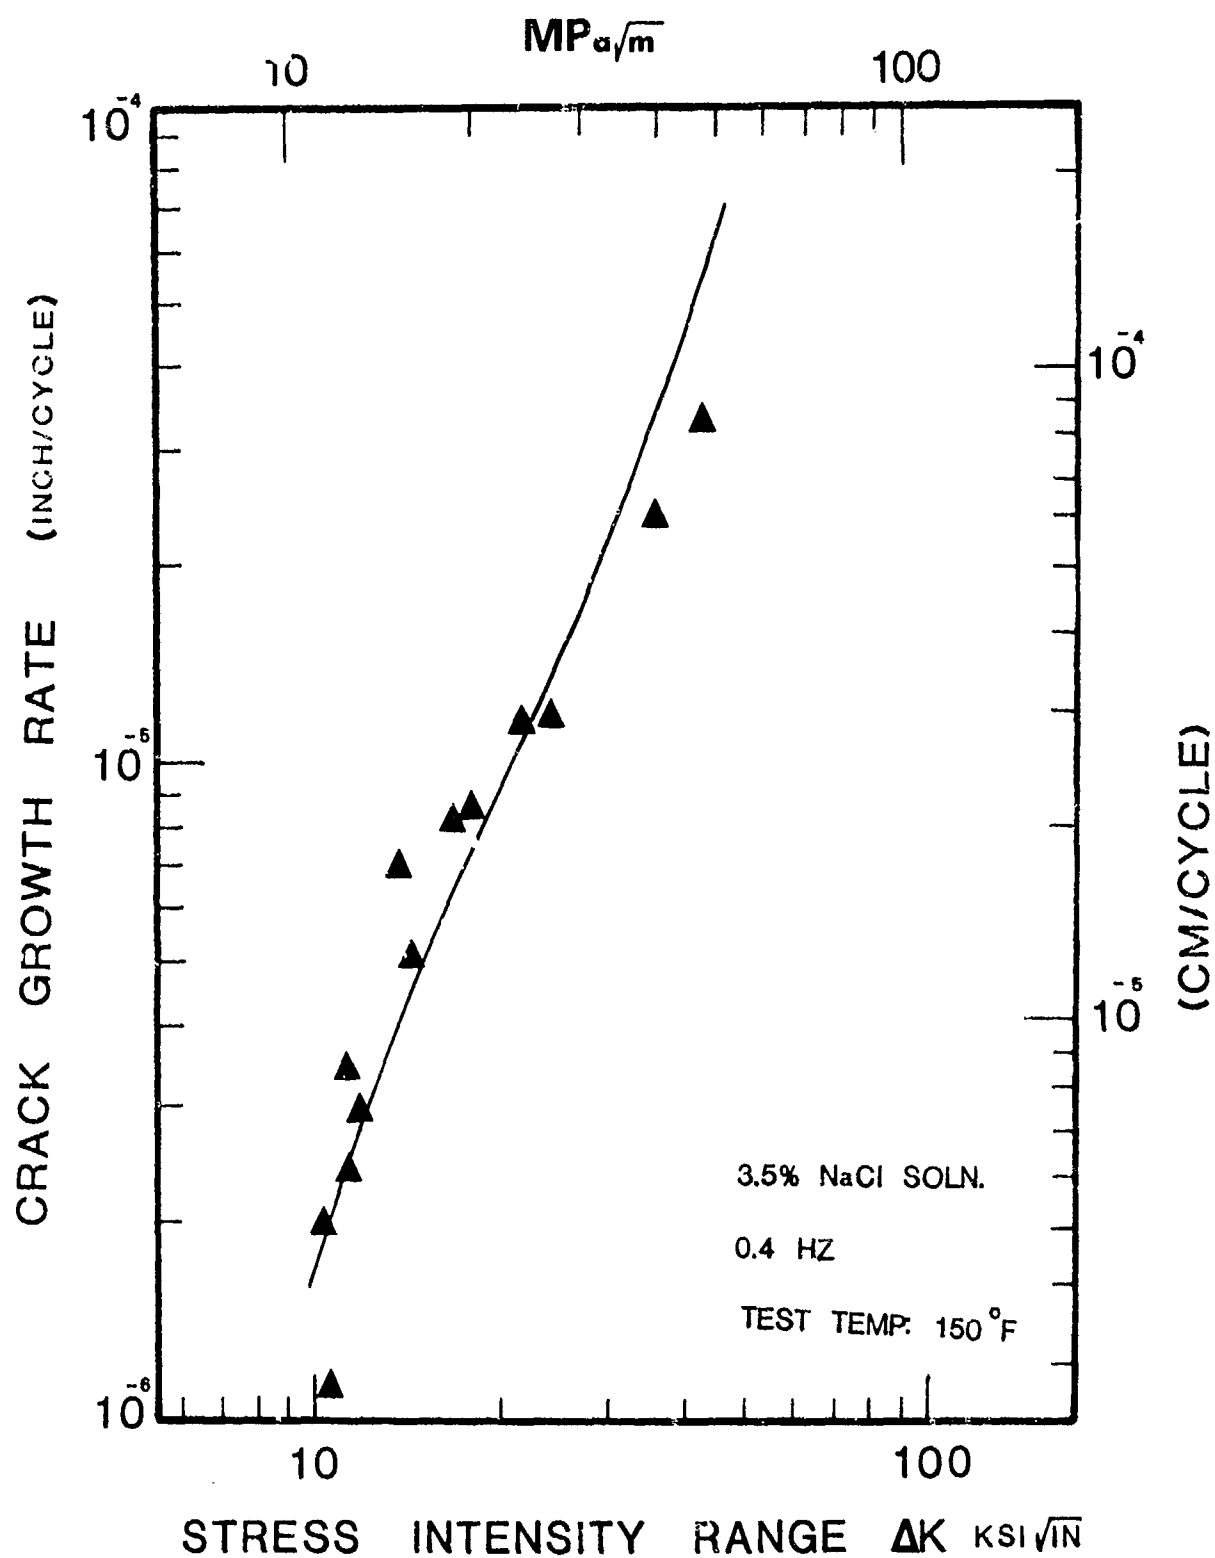
Fig. 21. FCP curve of AF-1410 steel, 950°F/5 hrs. age, in 3.5% NaCl solution, R=0.1, SEN specimen.

Fig. 22. FCP curve of AF-1410 steel aged at 950°F for 5 hrs. and tested in 3.5% NaCl solution. R = 0.1, SEN specimen.

Fig. 23. FCP curve of AF-1410 steel aged at 950°F for 5 hrs., tested in 3.5% NaCl solution. $R = 0.1$, SEN specimen, $B = 0.08$ ".

Fig. 24. FCP curve of AF-1410 steel aged at 950°F for 5 hrs., tested in 3.5% NaCl solution. R = 0.1, SEN specimen, B = 0.08".

Fig. 25. FCP curve of AF-1410 steel aged at 950°F for 5 hrs., tested in 3.5% NaCl solution.
R = 0.1, SEN specimen, B = 0.08 .

grips. Constant temperature was maintained by a Tempstir immersion heater/propeller device. The corrosion fatigue test results are shown in Figs. 21-26.

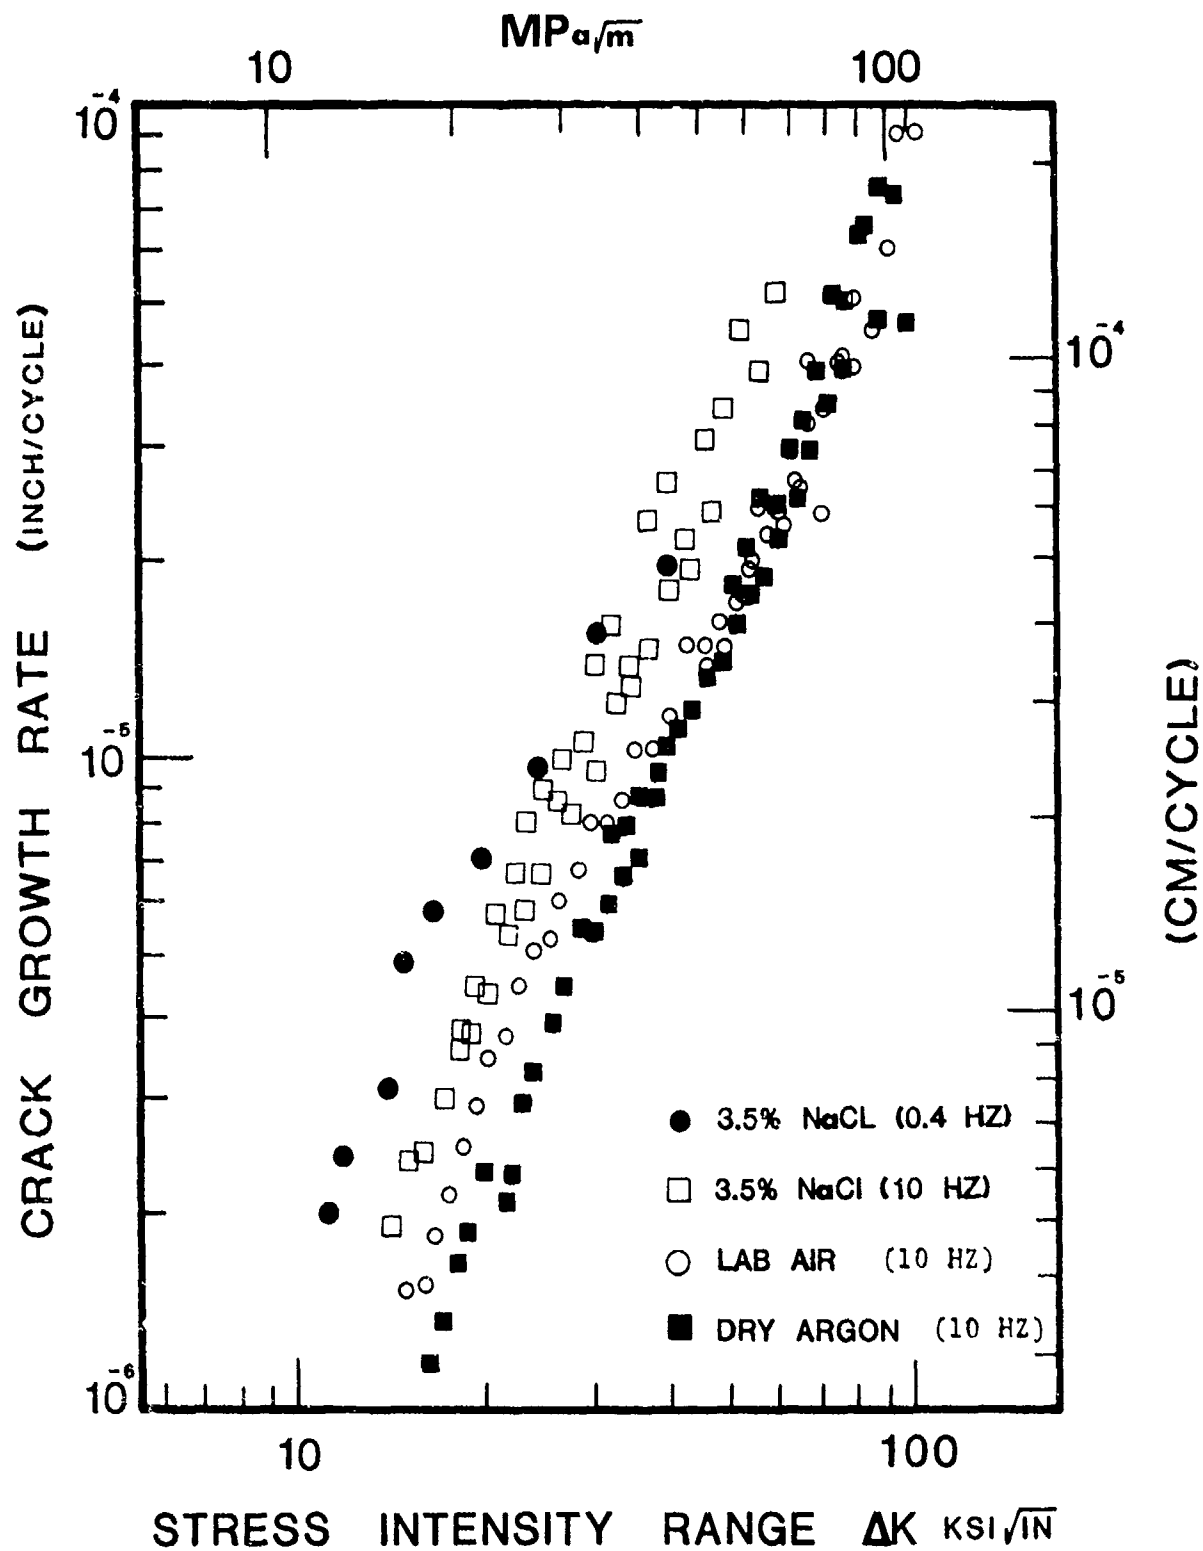
Fig. 26. Comparative fatigue crack growth rates of AF-1410 steel aged at 950°F for 5 hrs. Tested in different environments SEN specimens of 0.08" thickness were used at $R = 0.1$.

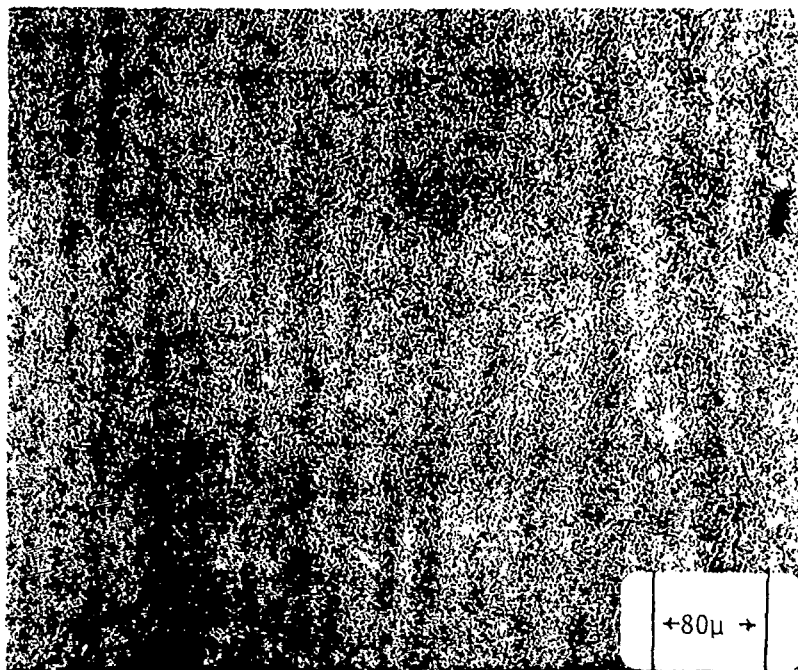
Fig. 27. Optical photomicrographs of A1-1410 steel
 (a) As-Quenced (annealed) microstructure. Note the banded structure.
 (b) 950°F/5 hrs. age microstructure. Grain size is ASTM # 16.

(c) Microstructure for the 750°F/5 hrs. age.

(d) Microstructure for the 975°F/5 hrs. age.

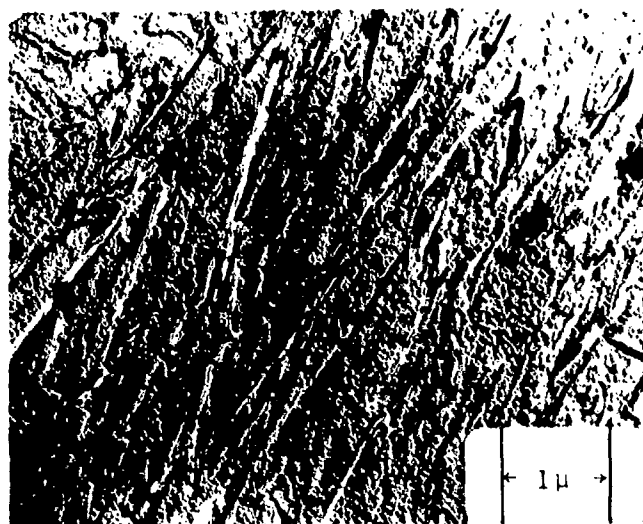
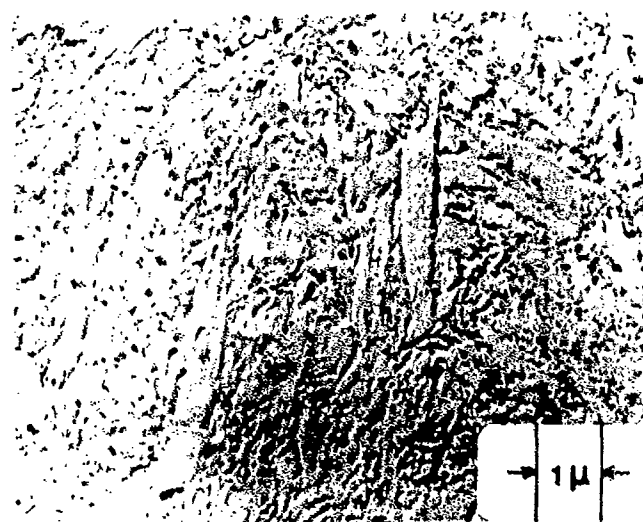
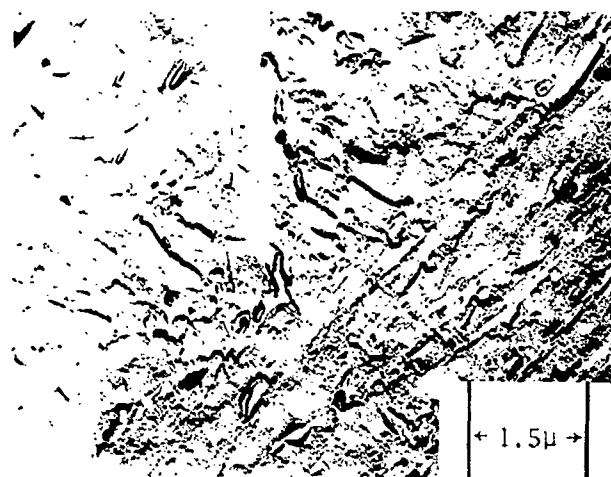
Fig. 28. Microstructure of AF 1410 steel as obtained by TEM replicas.
 (a) As-Quenched (annealed) micrograph showing the large carbides and plate shaped martensite laths.
 (b) 950°F/5 hrs. age. Fine $(\text{MoCr})_2\text{C}$ precipitates are seen.

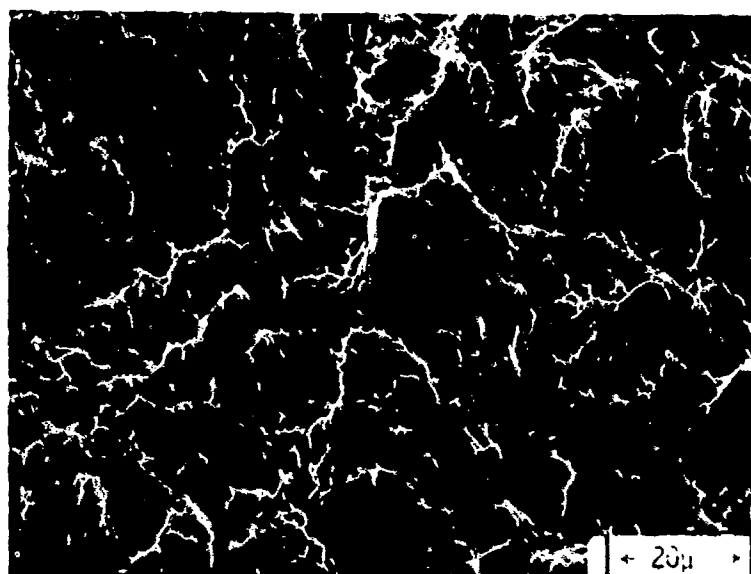
Fig. 38. SEM micrographs of the fracture surface of annealed LCF specimens. In (a) the origin of a low strain specimen is shown, while (b) is the overload region of the same specimen. In (c) the origin region of a high strain specimen is shown.

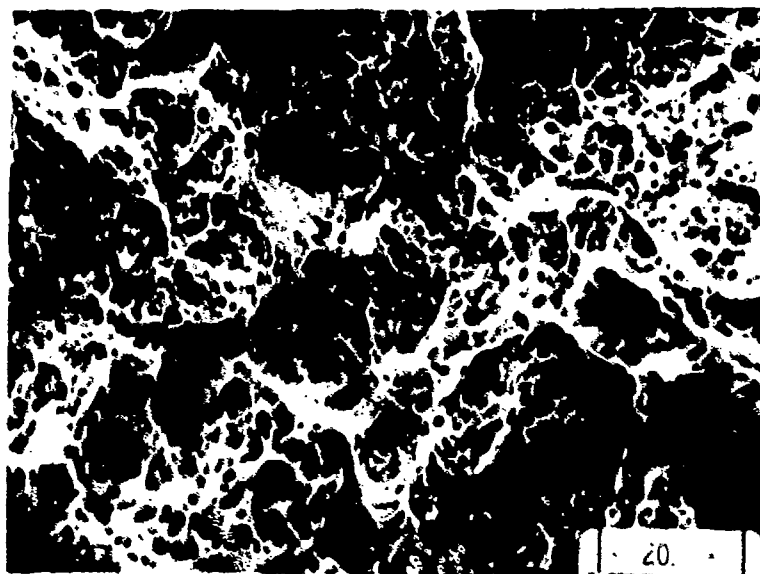
Fig. 39. SEM micrographs of the fracture surface of 950°F/5h aged LCF specimens. In (a) and (b) the origin and near-origin regions of a low strain specimen are shown while in (c) and (d) the near origin and overload regions of a high strain specimen are shown.

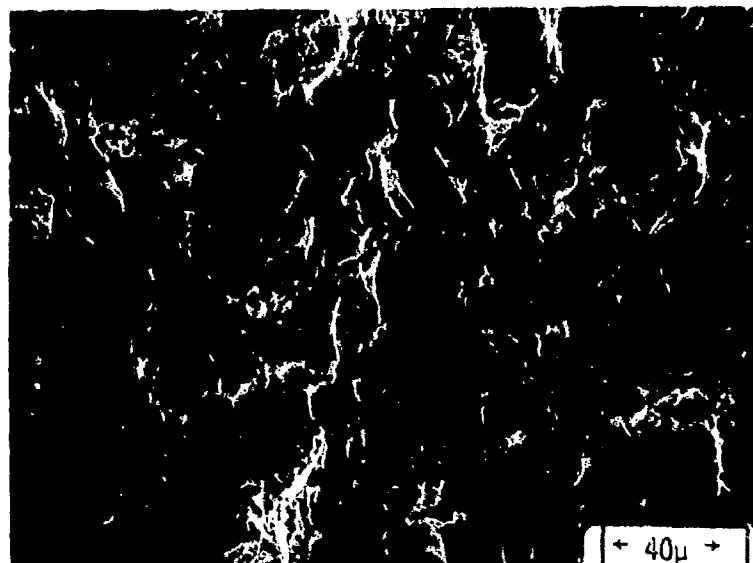
Fig. 40. SEM micrograph of LCF specimen aged at 750°F. The photograph was taken in the near-origin region.

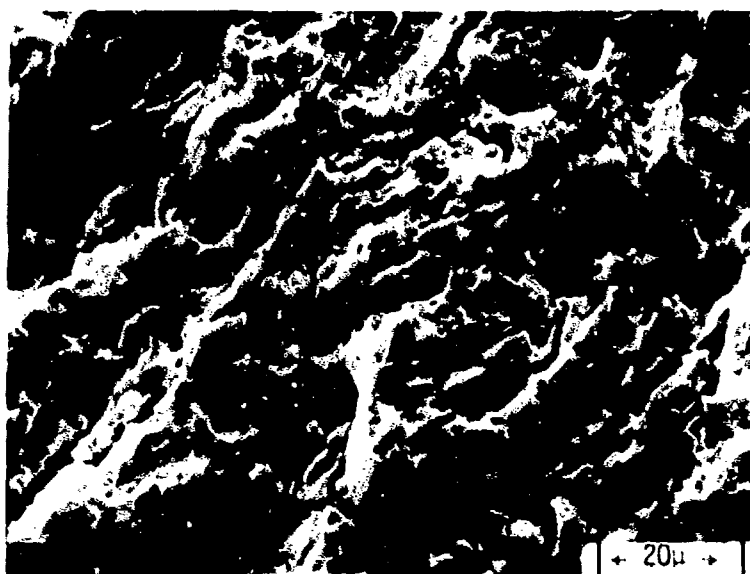
Fig. 41. SEM micrograph of fracture surface of LCF specimen that was aged at 975°F. The photo was taken in the near-origin region.

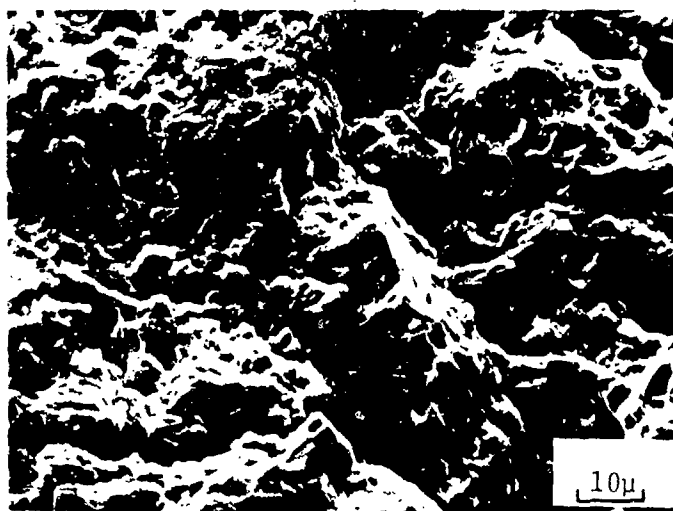
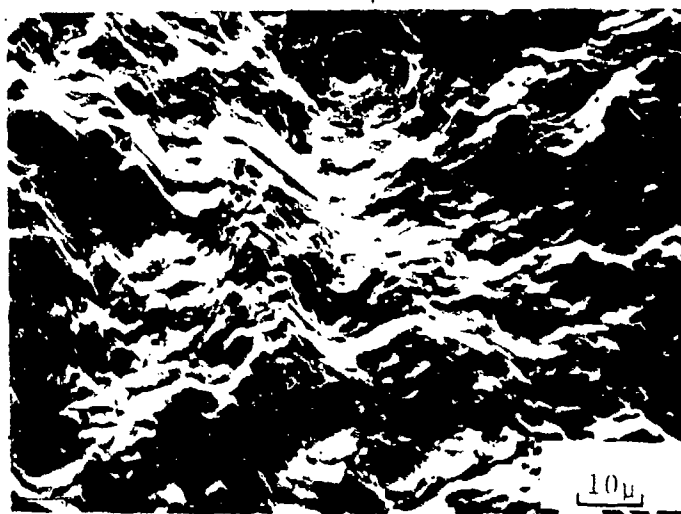
Fig. 45. SEM fractographs for 950°F for 5 hr. aged material at intermediate stress intensities.
 (a) Stereo-pair at a high stress intensity level. Fracture surface is rough and branch cracks are much larger than before. Again cracking is transgranular.

Fig. 45 (continued).
(b) Tensile overload region showing large dimples, indicative of normal rupture and brittle striations (marked C).
(c) Brittle striations and branch cracks.

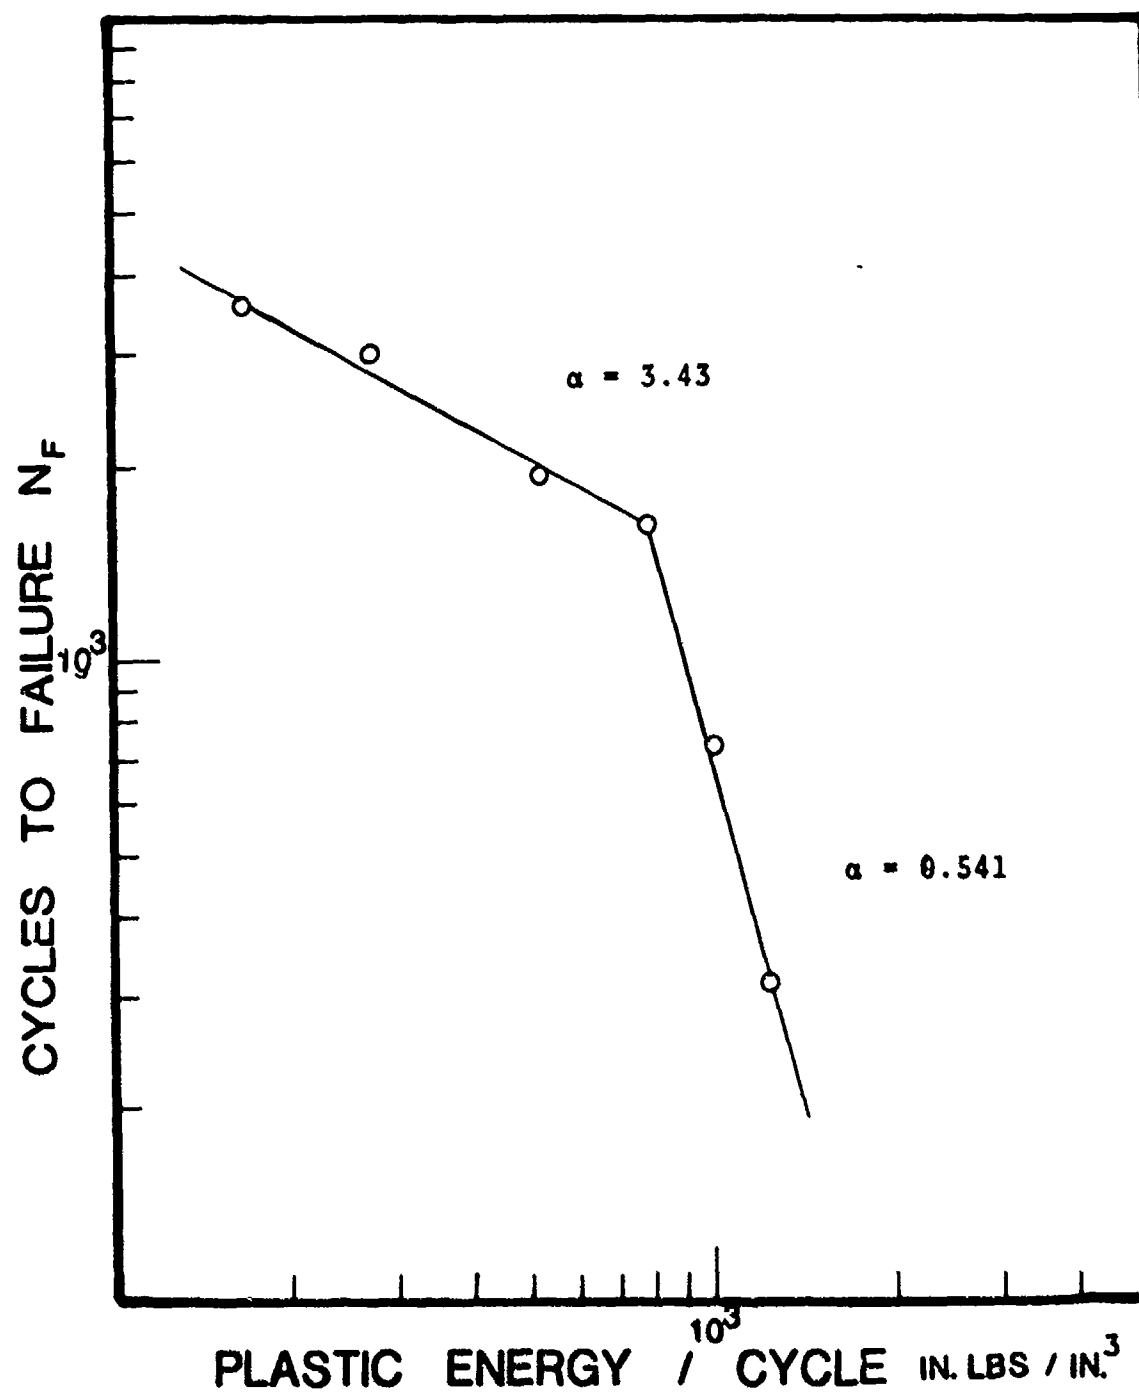
Fig. 49. Cycles to failure vs. plastic work/cycle for AF 1410 in the annealed condition.

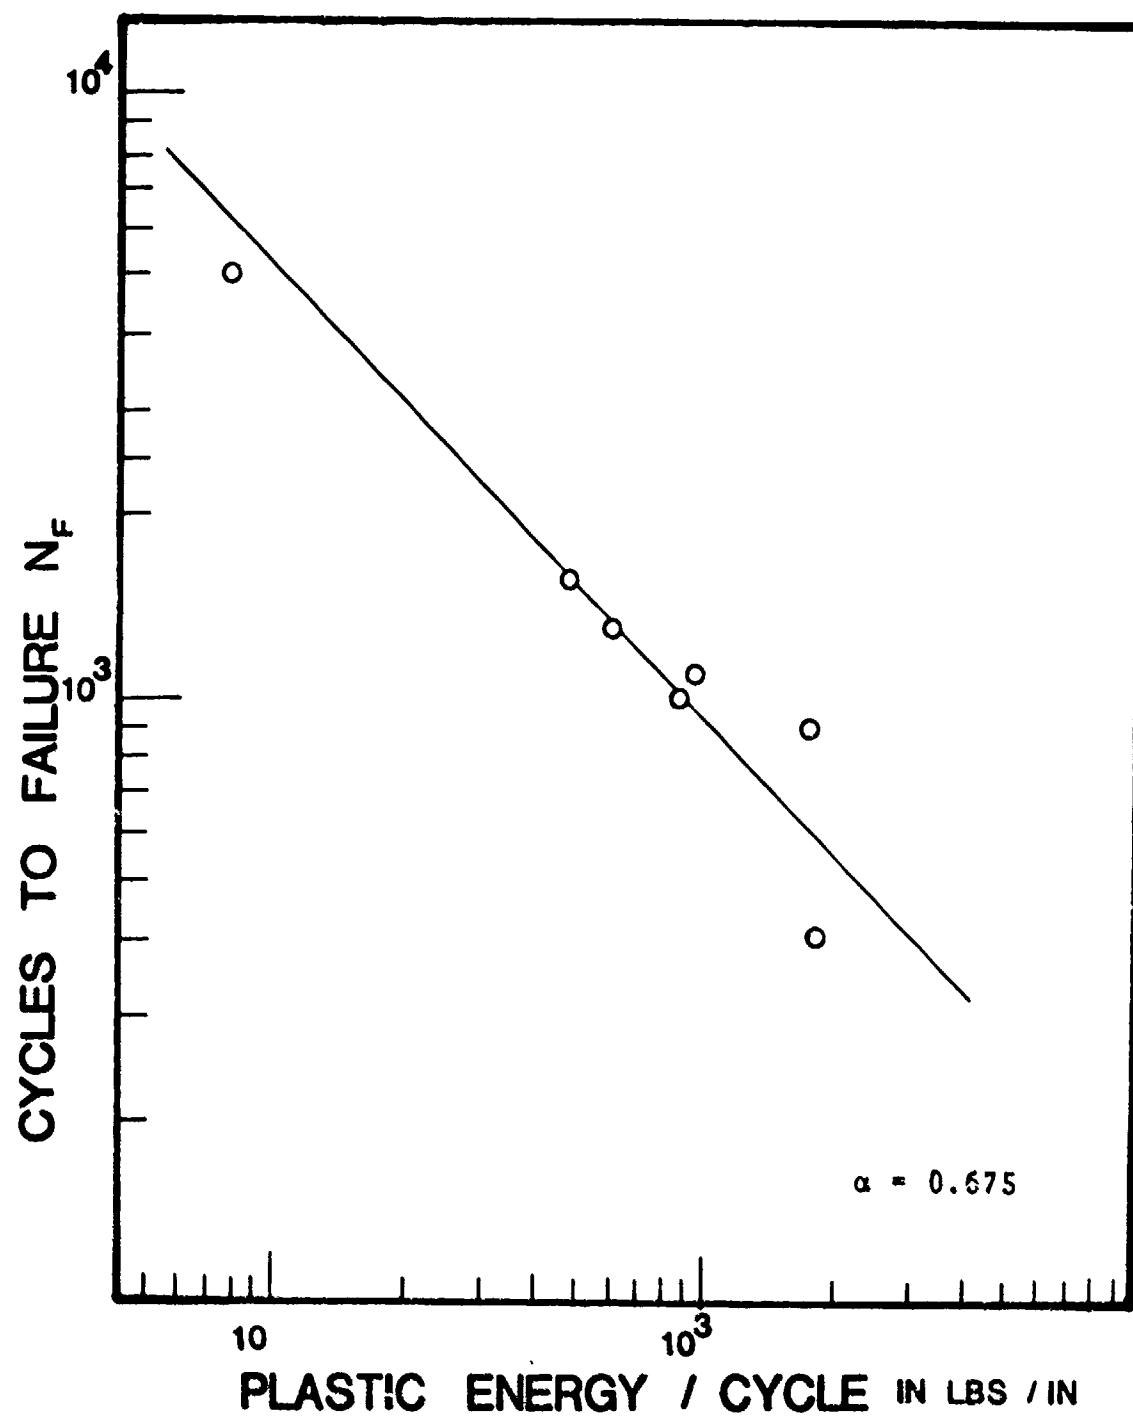
Fig. 50. Cycles to failure vs. plastic work/cycle for AF 1410 aged at 950°F for 5 hrs.

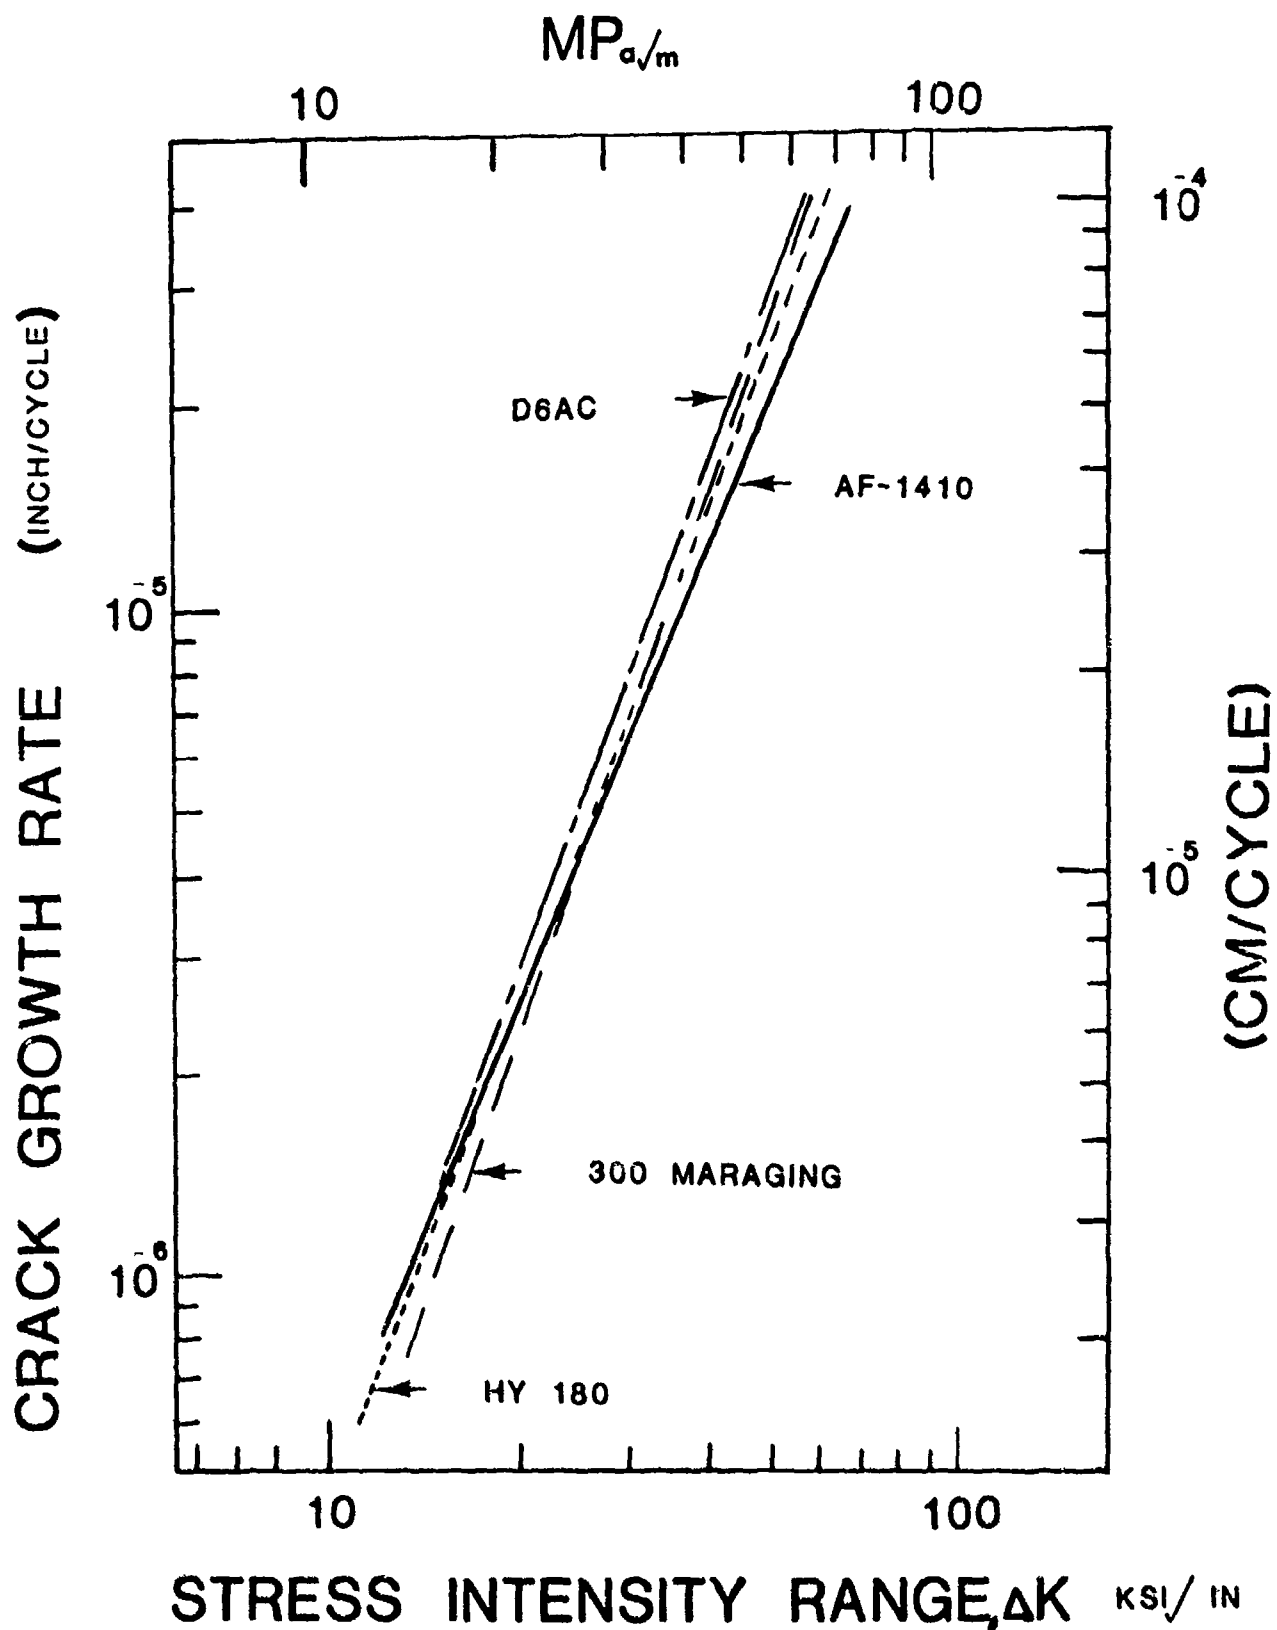
Fig. 51. Comparison of fatigue crack growth behavior of AF 1410 steel with D6Ac, HY 180 and 300 maraging steel. Data for these materials, except AF 1410 steel, obtained from ref. 28.
